# Manhole Inspection Summary

Manhole # S27E\_\_073MH

**Location** Address: **751 FREMONT ST**

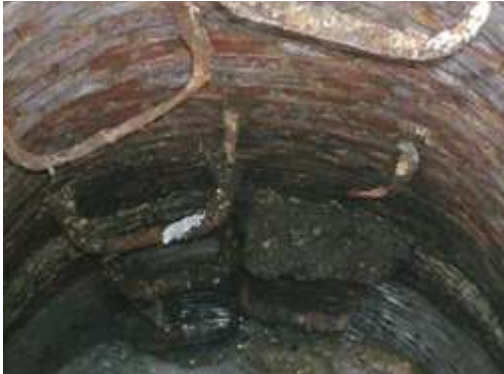
Defect 2

**Steps** Count: **9** Missing: **1** ☒ **Corroded**

**Surcharge** ☒ **Evidence Of Surcharge** Depth: **8** (ft.) ☐ Active Surcharge Present

CORRODED STEPS WITH SURCHARGE EVIDENCE, ONE STEP IS MISSING

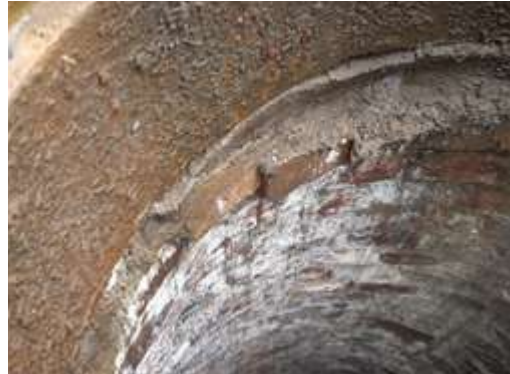
Defect 1

Condition: ☐ Sound ☐ Cracked ☐ Root Intrusion ☒ **Loose Brick** ☐ Deteriorated

LOOSE CORBEL BRICKS

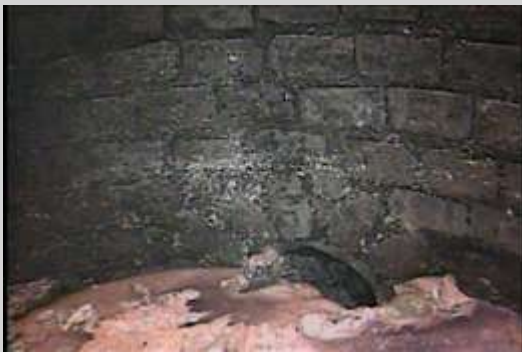
12 O'Clock Outflow

Pipe Height: **8.4** (in.) Rod and Bar (Angled)  
Pipe Material: **Clay** ☐ Pipe Lined  
Invert Depth: **14.85** (ft.) Flow Characteristics: **Slow**  
Deposits: ☐ None ☐ Mud ☐ Sludge ☒ **Debris** ☐ Grease  
Silt Depth: **3** (in.) Deposits Extent: **Medium**  
Infiltration: **None** Pipe Seal Cond: **Sound**

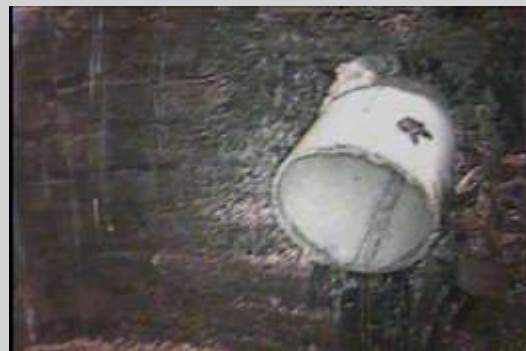
Drop In @ 9 O'Clock

LOOSE CHIMNEY BRICKS

Drop: **Inside** Rod and Bar  
Angled: **Yes** Reading: **12.31** (ft.)  
Inv Depth: **13.31** (ft.)  
Drop Condition: **Clogged**
